FIRE PERFORMANCE EVALUATION IN ACCORDANCE WITH NFPA 268-17, STANDARD TEST METHOD FOR DETERMINING IGNITIBILITY OF EXTERIOR WALL ASSEMBLIES USING A RADIANT HEAT ENERGY SOURCE

TRADE NAME: Qora Cladding Panel

REVISED FINAL REPORT Consisting of 9 Pages

SwRI® Project No.: 01.24921.01.148[1]

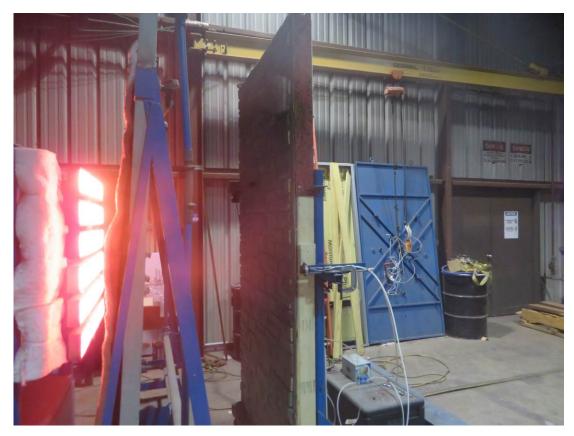
Figure B-1. Test setup.

A calibration test was performed on November 25, 2020, to establish the distance from the radiant panel to the calibration panel in order to maintain an average heat flux of $12.5 \text{ kW/m}^2 \pm 5\%$ for a 20 min period, as well as to verify that the average surface temperature of the radiant panel was $1600^{\circ}\text{F} \pm 50^{\circ}\text{F}$. The distance required to maintain the specified heat flux was measured to be 37 in. The heat flux was obtained by averaging the four heat flux meters located at the corners of the central square foot of the calibration panel. The heat flux at the center of the calibration panel shall not exceed 15 kW/m^2 or be less than 12.5 kW/m^2 . During both the calibration and the test, a side-mounted reference heat flux meter was located 5 in. from the vertical edge of the test specimen to the centerline of the gauge.

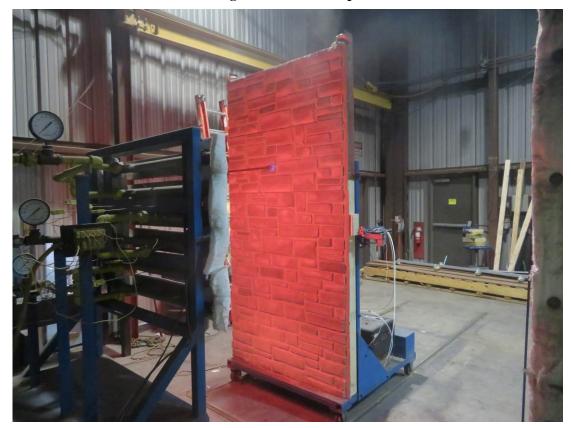
Figure B-2. Sample starting to smoke during fire exposure.

Time (min:s)	Observation
-1:00	Baseline
0:00	Start of test. Radiant heat shield removed.
2:10	Sample starting to smoke.
20:00	End of test.

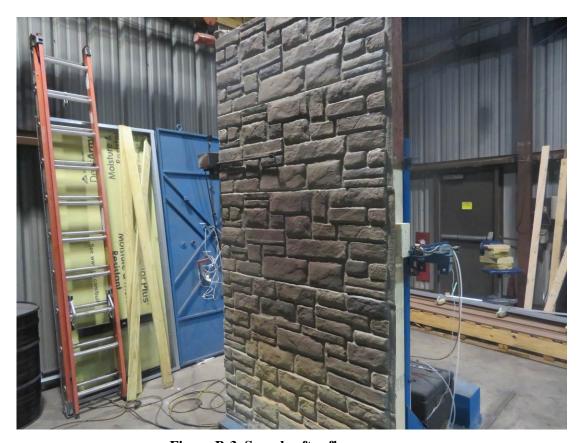
Figure B-3. Sample after fire exposure.

The wall assembly did not exhibit sustained flaming for a period greater than 5 s, which **meets** the acceptance criteria stated in NFPA 268. Graphical data and visual observations can be found in Appendix A, and photographic documentation is presented in Appendix B.
