TEST REPORT - 29504 A

Humidity Testing per ASTM D2247 for 336 hours.

ICC NTA Project #: AL060920-34
Product Name: Qora Cladding Panel
Manufacturer: Arcitell, LLC
Manufacturer Address:
750 Edelweiss Dr NE
Sugarcreek, OH 44681

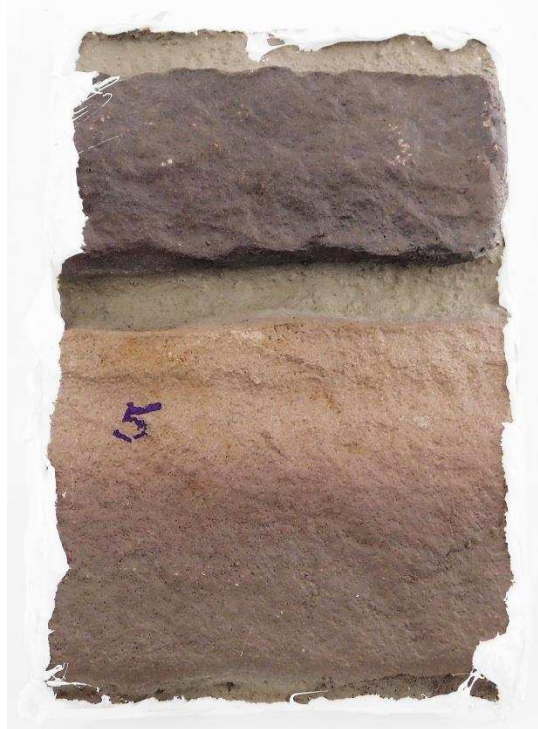
Sample #5 – Prior to Humidity exposure IAW ASTM D2247-15 (see above)

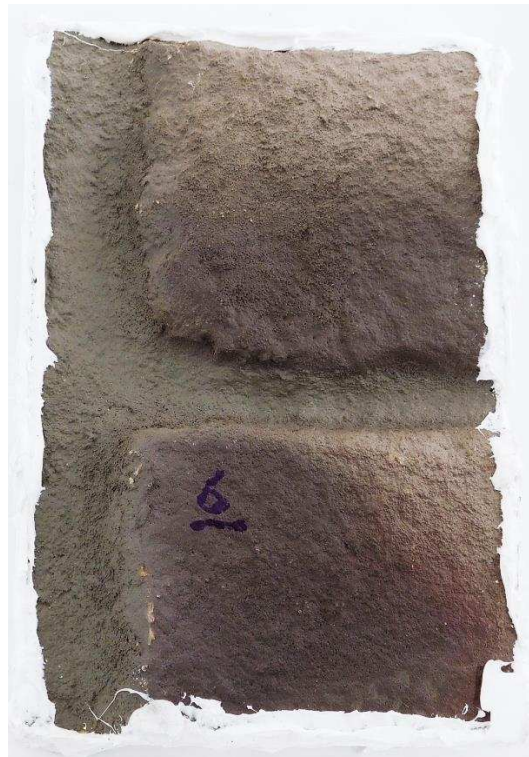
Sample #6 – Prior to Humidity exposure IAW ASTM D2247-15 (see above)

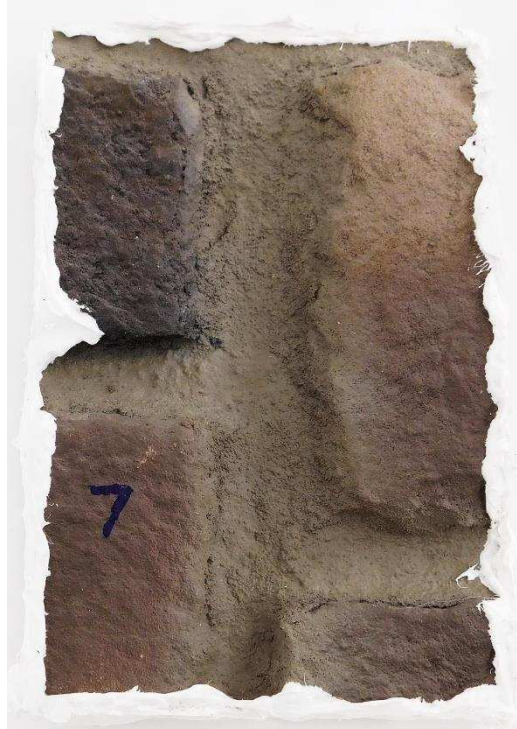
Sample #7 – Prior to Humidity exposure IAW ASTM D2247-15 (see above)

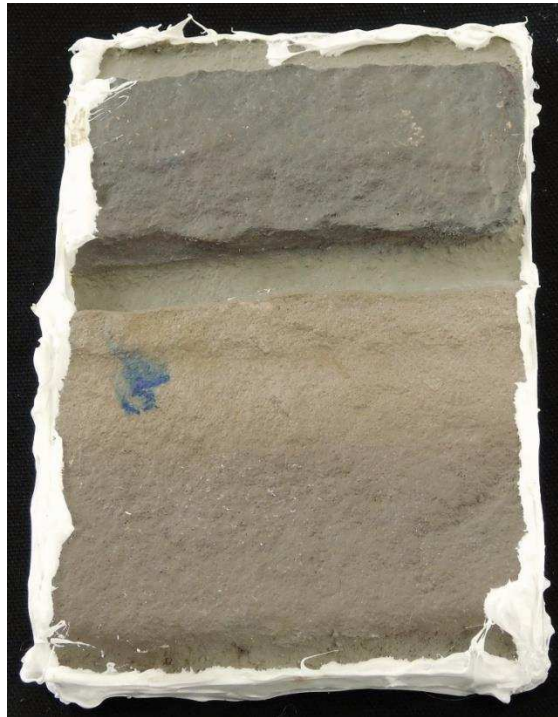
Sample #5 – At 336 hrs Humidity exposure IAW ASTM D2247-15 (see above)

<h3>Test Result</h3> <p>Results: See below.</p> <p>#5 - PASS with no deleterious effects #6 - PASS with no deleterious effects #7 - PASS with no deleterious effects</p> <p>Customer Requirement: Condition of acceptance is that at the end of the test there are no deleterious effects (e.g. cracking, checking, crazing, erosion, delamination) observed that may affect performance as an exterior wall covering.</p> <p>Back sides and edges of samples were masked by ICC.</p>	Test Name/Procedure	Humidity ASTM D2247-15		
	Requirement Specification	Customer specified		
	Customer Material Specification			
	Part Number			
	Lot Number			
	Sample Description	4" x 6" Qora cladding samples		
	In Date	14-Dec-20		
	Out Date	28-Dec-20		
	Test Count	3		
	Return Count	3		
	Cycles		Hours	
	Required		Required	336
	Hours/Cycle		Completed	336
	Completed

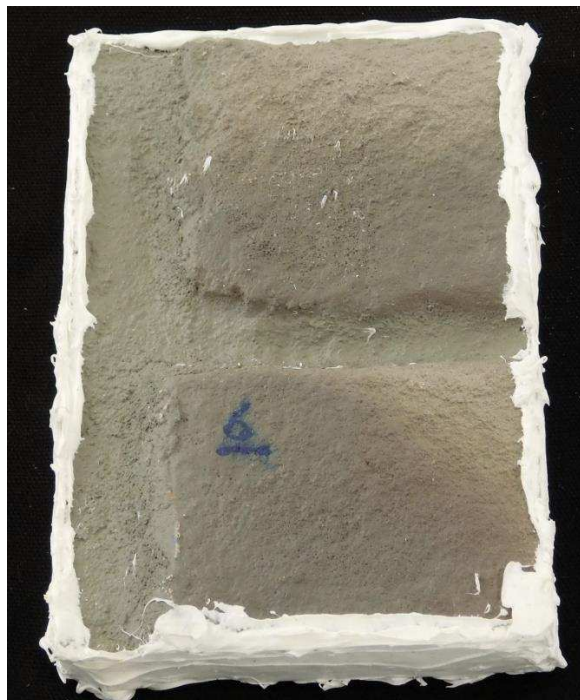
Sample #6 – At 336 hrs Humidity exposure IAW ASTM D2247-15 (see above)

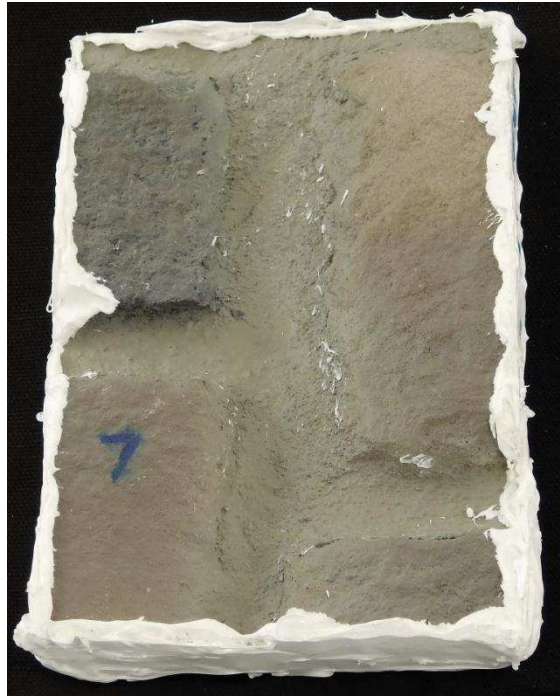
Sample #7 – At 336 hrs Humidity exposure IAW ASTM D2247-15 (see above)
